## Scanning Electron Microscopy Imaging of Microcracks and Charging Phenomena on a Laser-Damaged $\text{CaF}_2$ Surface

**Summary:** Systematic scanning electron microscopy (SEM) investigations of charging phenomena on a laser-damaged  $\text{CaF}_2$  surface have been carried out as a function of primary electron energy. To this purpose, we imaged an uncoated trapezoidal area of about  $400 \mu\text{m}^2$  surrounded by a carbon-covered surface at ground potential. It was located at the periphery of a laser-fractured spot and contained microcracks that served to define the local contrast. Areal surface charging was inspected by comparing the brightness of the uncovered area with that of its surrounding. Microcracks were imaged using backscattered (BSE) and secondary (SE) electrons, and optimal imaging conditions were established for both techniques. The best contrast of the fracture pattern was obtained with 20 keV primary electrons in BSE composition mode. In SE mode, the microstructure was more or less blurred, except for 5 keV and  $25^\circ$  surface inclination where the cracks showed an enhanced SE emission, which might originate from occupied defect states in the band gap.

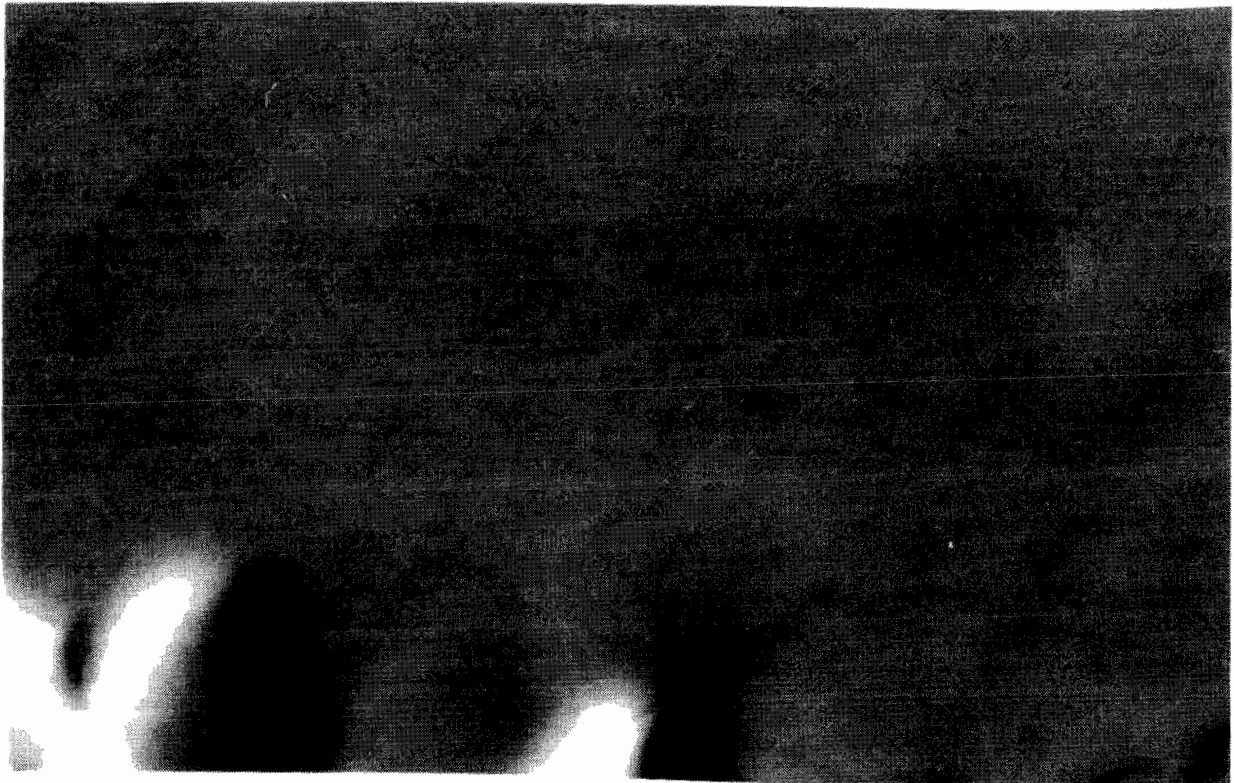
FIG. 5 Backscattered electron image in topography mode for  $E_p = 20$  keV at perpendicular incidence. The trapezoidal area shows no topographic contrast. Features in the lower part of the picture represent missing or bent-up fragments outside  $T_c$ . Horizontal field width =  $39 \mu\text{m}$ .

The pictures in Figure 4a–d were taken in additive composition mode which eliminates any topographic contrast. In order to check that there are indeed no topographic features present inside  $T_c$ , the same area was scanned in topographic mode. ( $S_1$ – $S_2$ ), with 20 keV primary electron energy as used for Figure 4a. The result is displayed in Figure 5. Comparison with Figure 4a reveals that within the trapezoidal area there are no bent-up edges and the surface, although penetrated by microcracks, is perfectly flat. At the boundary toward higher laser damage, however, the topographic contrast shows edge contours of missing fragments. Again, the high primary electron energy of 20 keV rules out any influence of charging.

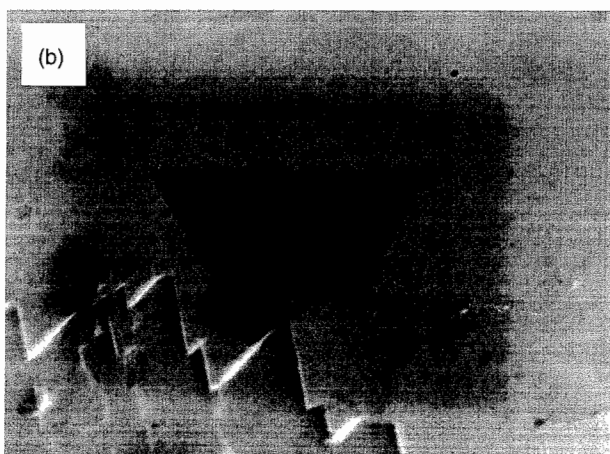
FIG. 7 Contrast inversion in secondary electron imaging at  $\phi=0^\circ$  and low primary energies in the range  $E_1 < E_p < E_2$ , to illustrate a variation of  $\delta_{SE}$  for carbon in this energy range. (a)  $E_p=1.5$  keV, microcracks and polishing scratches clearly visible, (b)  $E_p=0.5$  keV, visibility of all surface details strongly reduced. Horizontal field width = 64  $\mu\text{m}$ .

where  $I_c$  and  $I_u$  are the SE intensities from coated and uncoated areas, respectively. Another important observation is that in Figure 7a and b the information about microcracks is lost, perhaps more completely in Figure 7b. This would indicate a stronger positive charging at  $E_p = 0.5$  keV. Furthermore, it is interesting to note in Figure 7b that compared with Figure 7a, also in the vicinity of  $T_c$ , fracture features cannot be recognized anymore. For a primary energy of 0.5 keV, the range of electrons in carbon is about 15 nm (Fitting 1974) and corresponds to the thickness of the carbon layer. Under these imaging conditions, the maximum depth of information of the SEs cannot be larger than the depth of the carbon layer and, therefore, the SE image does not reflect features from the surface of the  $\text{CaF}_2$  crystal. Notice also that the imaging conditions were identical in Figures 6d and 7a.

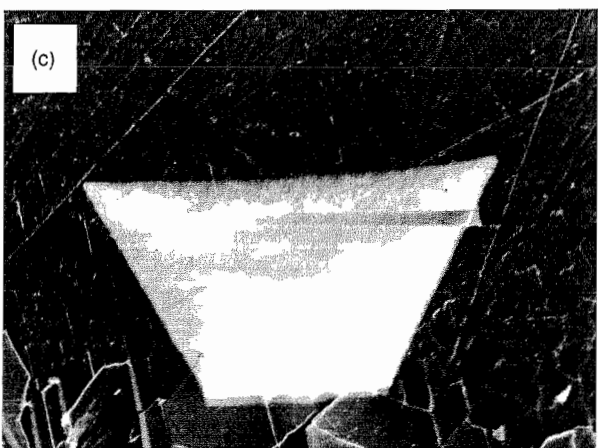
FIG. 8 Secondary electron imaging of  $T_c$  for different primary electron energies at  $\phi=25^\circ$ . (a)  $E_p=20$  keV, negative charging, fringe retardation, sharp microstructure; (b):  $E_p=5$  keV, weak negative charging, fringe retardation, microstructure visible; (c):  $E_p=2.0$  keV, weak positive charging, faint microstructure; (d):  $E_p=1.0$  keV, strong positive charging, faint microstructure. Horizontal field width for (a), (c), (d), =  $36 \mu\text{m}$  and for (b) =  $39 \mu\text{m}$ .

Figure 8 displays SE images recorded with different primary energies at a tilt angle of  $\phi = 25^\circ$ . Again the detector was at an accelerating bias of several hundred volts. The inclination reduces the areal contrast by  $\cos^2\phi = 0.82$  but enhances the topographic contrast outside the trapezoidal area. According to Reimer *et al.* (1992), the critical energy is now  $E_2 = 2.3$  keV. Again, the areal contrast of  $T_c$  varies strongly from  $E_p$ . However, charging is compensated in part by the  $\cos^{-1}\phi$ -dependence of SE emission on  $\phi$ . In Figure 8a, the effective energy is 16.4 keV and the surface carries a negative charge. Microcracks are clearly visible but appear bright, indicating an enhanced SE emission. The brilliance of  $T_c$  is amplified by primary electrons scattered into the detector. The negative charging becomes much weaker in Figure 8b, with the effective (corrected for  $\phi$ ) primary energy approaching  $E_2$ . The microcracks can still be seen as bright lines, but are not as sharp as observed with higher energy in Figure 8a. In Figure 8c, the trapezoidal area is positively charged but, because of

the ratio  $\delta_{SE}(CaF_2)/\delta_{SE}(C) \approx 3.2$ , it still appears brighter than the carbon surrounding. The positive charge-up is still stronger in Figure 8d, but a major fraction of SEs is bent or retracted to the surface. Consequently, the trapezoidal area turns darker despite the fact that more SEs are expected to leave the surface at such low primary energy.

Concerning local information, microcracks are barely visible in Figure 8c and d and appear, if at all, as faint dark lines. This points toward reduced SE emission out of cracks at low primary energies, possibly because they are held back by the positive charge-up. The opposite happens for  $E_p > E_2$ , where microcracks appear as bright lines in Figure 8a and b, implying stronger SE emission from fractured areas. Geometrical edge effects can be ruled out by the even appearance of the microcracks. Also, the topographic contrast in Figure 5 shows that the surface of the trapezoidal area is perfectly flat without upcast edges. To interpret the bright lines, we note that the tilt of the sample opens the path for electrons from inside the cracks toward the detector, and we suggest that  $\delta_{SE}$  is enhanced at or near the walls of microcracks. The reason is sought in more weakly bound occupied states within the band gap of insulators (Bommakanti and Sudarshan 1990). Such electronic states are expected for structural defects such as fractured planes, steps, and dislocations. Although the bright pattern of microcracks can be well recognized in Figure 8a and b, SE imaging at  $\phi = 25^\circ$  does not provide by far such distinct fracture contrast as that obtained in BSE composition mode with high primary energies (compare Fig. 4a).
